The Effects of Surface Runoff on Hart Prairie from Arizona Snow Bowl Facilities, Coconino National Forest

Richard Hereford, Research Geologist Emeritus

Spring 2023

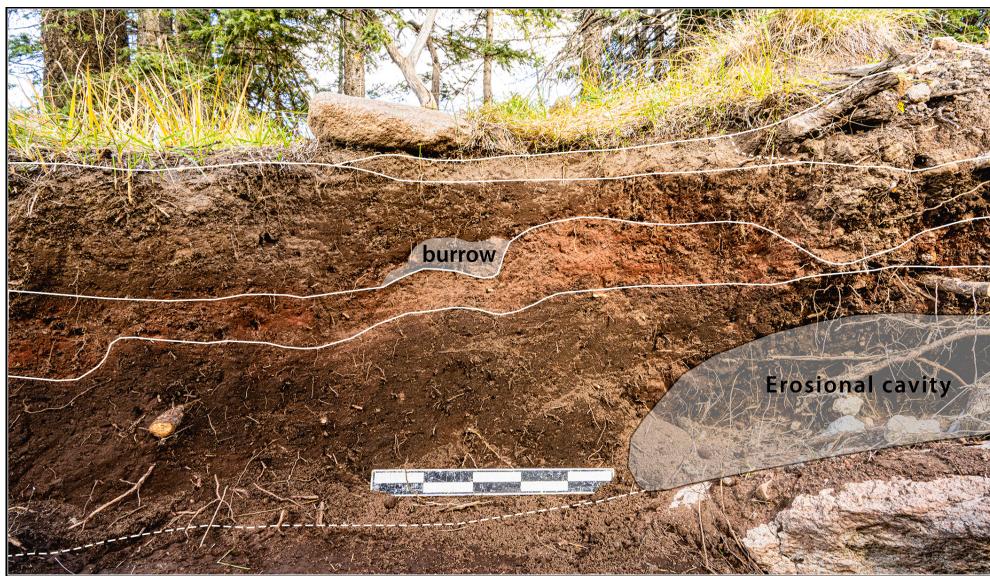
Unit 4. Very fine to coarse sand, silty, clayey, grayish brown (5YR 3/2), grades upstream (right) to light gray (N8) coarse sand with granule to small pebbles of andesite and dark basaltic cinders, possibly related to fallen aspen trunk blocking stream flow

Unit 3. Fine to medium sand, clayey, scattered red cinders, grayish brown (5YR 3/2)

Unit 2. Granule to small pebble size cinders, distinctive light red (5R 6/6), upper part truncated downstream

Unit 1. Very fine sand, silty, clayey, medium dark gray (N3), overlies large debris fan boulders, possible A horizon

FIGURE 3 Stratigraphic section of alluvium deposited by stormwater runoff (units 2-4). Exposure in gully about 55 ft downstream of sample culvert (fig. 2). Red cinder bed (unit 2) was derived from red cinders applied to west shoulder of FR 516 before June 2011 and by May 2012. Scale 50 cm (1.6 ft).

Evidence of earlier surface runoff and the related erosion of upper Hart Prairie is the presence of "soils" or sedimentary deposits from runoff events that post-date October 1997. These consist of four mapped occurrences of silty to small pebble-sized gravel eroded from the basin, dark basaltic cinders applied to roads and parking lots, cobble-size asphaltic clasts, and a variety of litter (fig. 2). Litter in the stormwater is deposited on the prairie along with the sediment; it consists of aluminum cans, face masks, miscellaneous colored plastic fragments, and various clothing items. Face masks are diagnostic of the July 2021 runoff. The various occurrences extend up to 900 ft beyond the SPUA boundary. Three of them originated from exit culverts of the drainage system. The fourth and northernmost deposit and 630 ft of its related channel were removed or covered by the fill used to construct Lot 5.

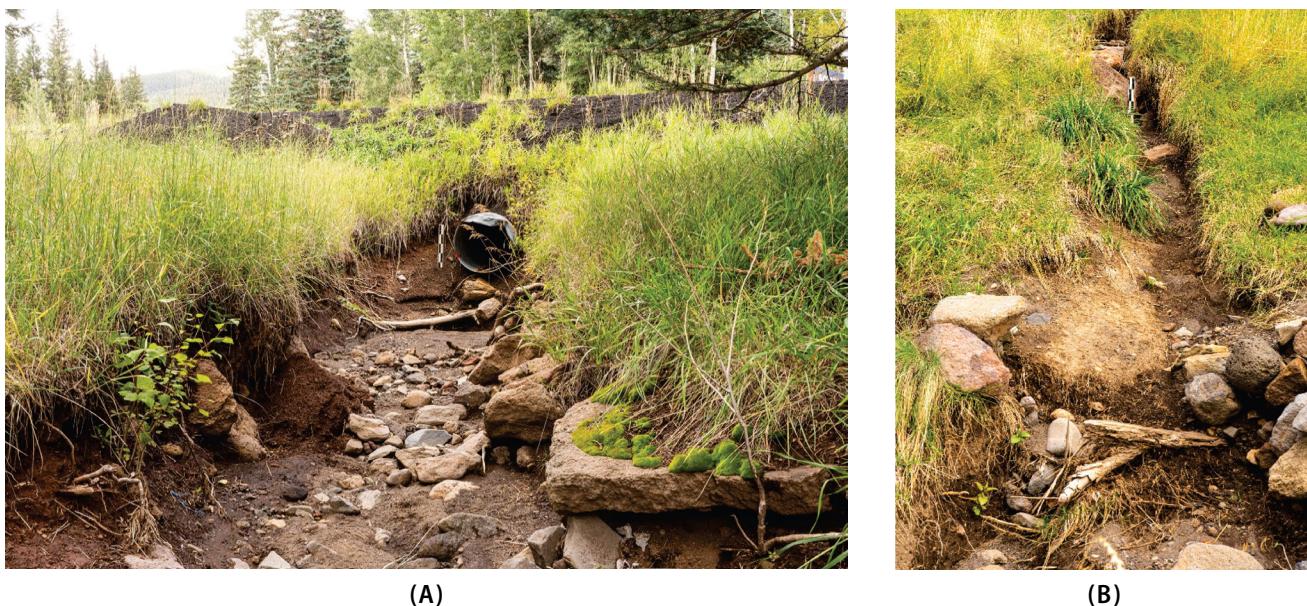
FIGURE 4 Upstream views of gully related to runoff at the sampling and measurement locality (fig. 2). (A) Gully at culvert incised since 2011 (Table 1). (B) Gully 220 ft downstream from culvert; knickpoint (abrupt channel steepening) in foreground. These migrate upstream and downstream widening and deepening the channel. Scale 50 centimeters (1.6 ft).

The initial erosion of the southwest side of upper Hart Prairie fan, mentioned above, is related to the final installation of the two-component drainage system in 2012. Incision of the gully is documented by a stratigraphic section of alluvium deposited by stormwater (fig. 3). The alluvium is exposed in the gully 55 ft downstream of the sample and measurement culvert (fig. 2). The section consists of four units (or beds) that overlie the bouldery deposits of the much older Hart Prairie debris fan, which is probably mid- to latest Pleistocene (Youberg and Ben-Horin, 2021). The lowest bed in the sequence is a dark-colored clay-rich soil, probably an A-horizon (unit 1), formed on the bouldery fan deposits. A distinctive light red bed of basaltic cinders (unit 2) overlies the eroded surface of unit 1. Deposition of this bed, as explained below, resulted from the first runoff onto the southwest side of the prairie. The cinder bed, in turn, is overlain by a bed of silt-to-sand-size sediment containing scattered red cinders (unit 3). The surface of the stratigraphic section is formed on clayey sand with small pebbles of andesite bedrock (unit 4). The cinders were eroded from the west shoulder of FR 516. Based on the satellite imagery, a narrow band of red material was placed on the road's shoulder sometime after June 2011 and before May 2012. The gully was not present when units 1 to 4 were deposited. Thus, the present gully (fig. 4) was probably incised during the summer of 2013 and certainly before April 2015 (Table 1). From 2012 to the present, modifications, and additions to the drainage system expanded deposition and gullying on the prairie to the three sites south of Lot 5.

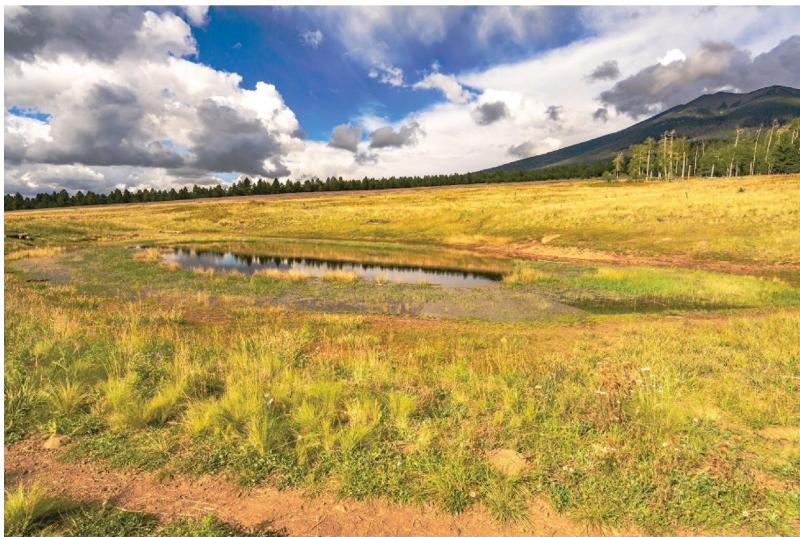
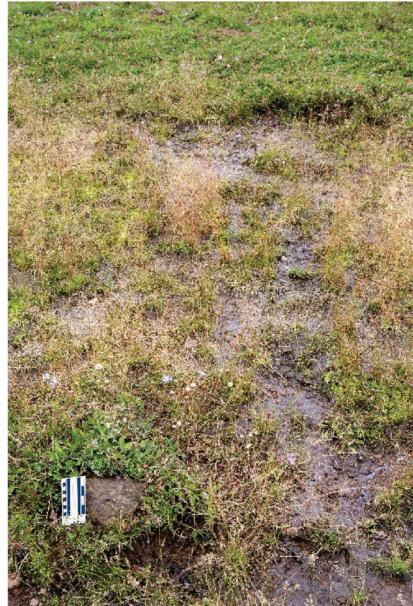
FIGURE 6 Alfa Fia tank and seeps southwest of Snow Bowl. (A) Mapped path of runoff on Hart Prairie, July 18, 2021. (B) Alfa Fia tank with Snow Bowl basin upper right skyline, and (C) one of two seeps feeding tank on distant shore of earthen tank, September 9, 2022 (scale 10 cm).

earlier runoff on the southwest side of the fan was not found. The trajectory of this runoff was directed toward Alfa Fia tank, a perennial constructed earthen stock tank fed by two seeps. Larger flows, such as the 21.7 cfs of summer 2021 and the earlier 32.7 cfs would likely reach the tank (fig. 6).
